2018 Annual Report

East Bethel – Ham Lake – Linwood - Columbus

April 11, 2019

Sunrise River Watershed

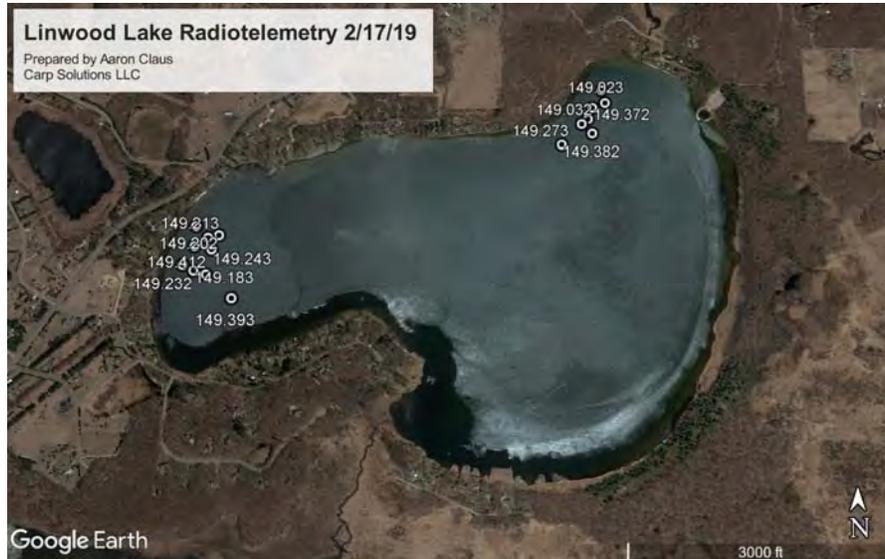
Locations of Linwood Lake radio tagged carp, revealing the carp's preferred locations in the lake and seasonal spawning movements which can be used in management efforts.

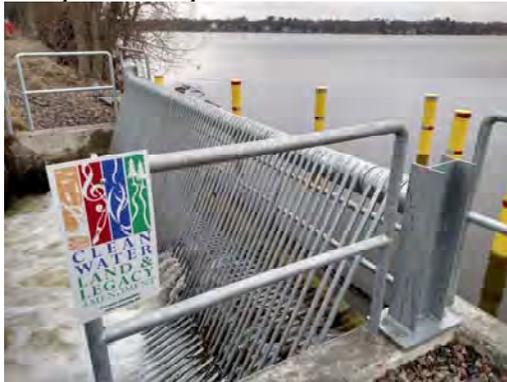
Martin Lake Outlet

Completed carp barriers

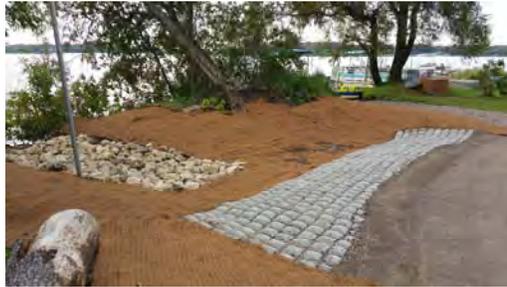
Lincoln Drive Stabilization

Completed Coon Lake Stormwater Retrofits

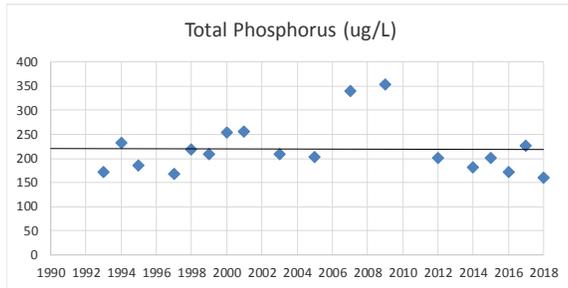
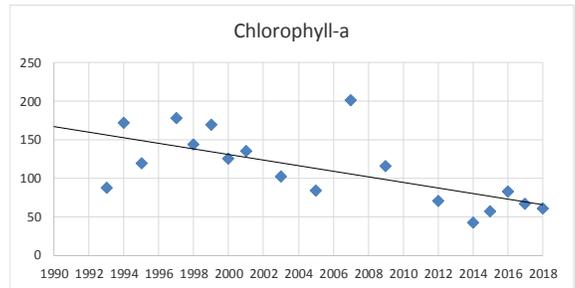
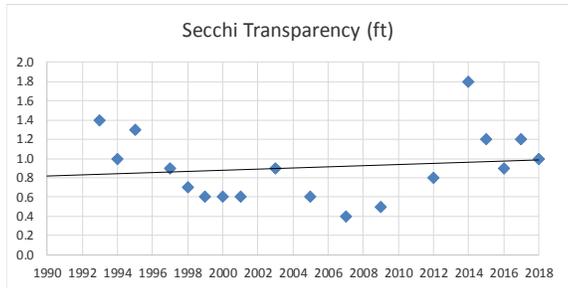
Typo Lake Water Quality Data Showing Trend Lines

Typo Lake's water quality improvement appears to be primarily a reduction in algae (as measured by chlorophyll-a). A test that incorporates the correlated factors of total phosphorus, chlorophyll-a and Secchi transparency found statistically significant water quality change (repeated measures MANOVA with response variables TP, Cl-a, and Secchi depth; $F_{2,15}=5.6$, $p=0.02$). If these factors are examined separately with one-way ANOVAs, Cl-a has a statistically significant decline ($p<0.001$), while total phosphorus and Secchi transparency show no statistically significant change.

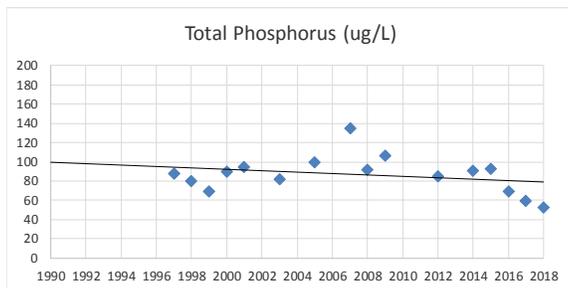
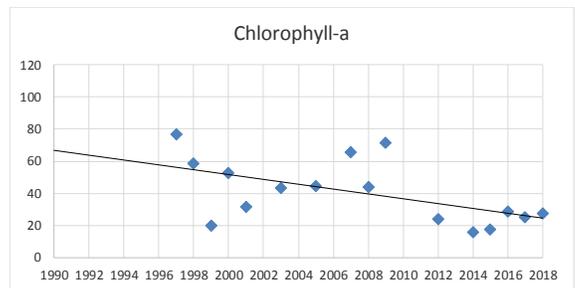
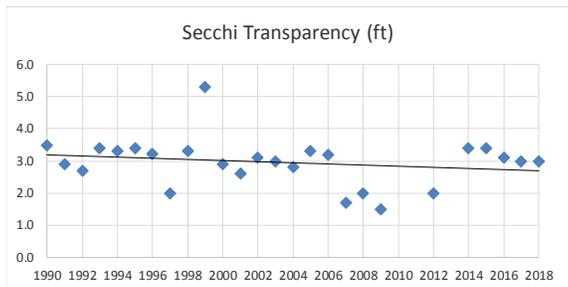
Martin Lake Water Quality Data Showing Trend Lines

Martin Lake’s water quality improvement also appears to be primarily driven by algae reduction. A test that incorporates the correlated factors of total phosphorus, chlorophyll-a and Secchi transparency found statistically significant water quality change (repeated measures MANOVA with response variables TP, Cl-a, and Secchi depth; $F_{2,14}=5.33$, $p<0.05$). Further examination of the data (one-way ANOVAs on the individual response variables) shows that while TP and Secchi depth appear to be staying virtually flat, while Cl-a has shown a statistical decrease ($p<0.01$).

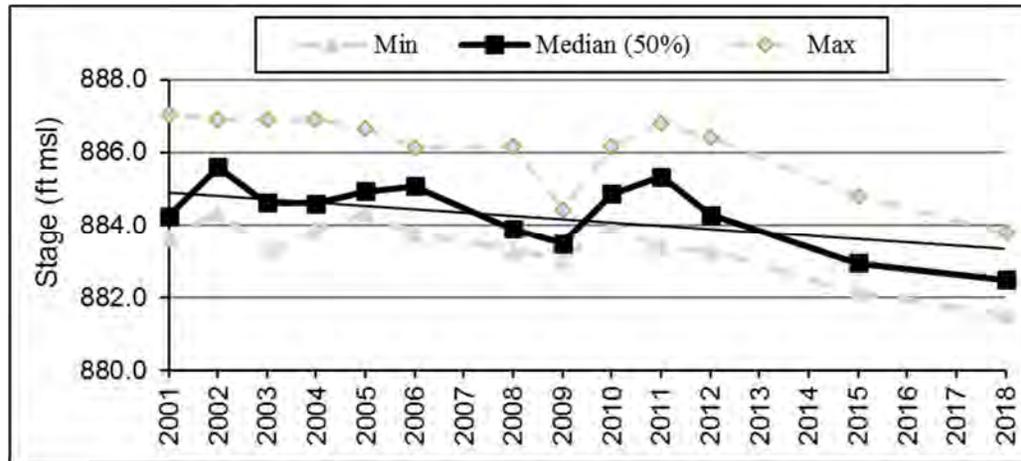
97.5%	886.90	886.82	887.61	885.65	885.75	887.05	886.84	886.74	886.82	885.92	886.06	886.04	884.31	885.94	886.76	886.36	884.15	883.61
Max	887.13	887.14	887.81	885.77	886.02	887.05	886.89	886.91	886.89	886.67	886.14	886.17	884.42	886.18	886.79	886.41	884.80	883.79

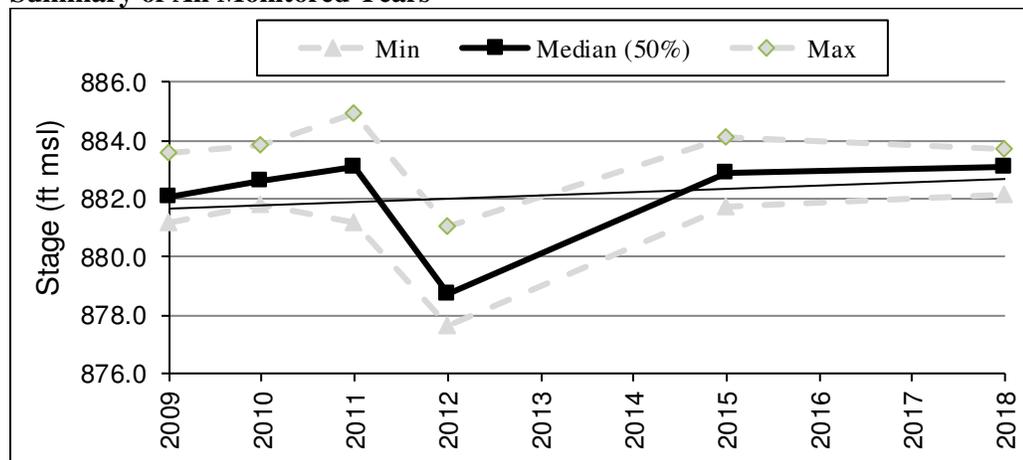
Summary of All Monitored Years

Percentiles	2009	2010	2011	2012	2015	2018
Min	881.20	881.77	881.16	877.64	881.75	882.14
2.5%	881.34	881.91	881.28	877.90	882.01	882.24
10.0%	881.57	882.02	881.57	878.10	882.25	882.49
25.0%	881.74	882.17	882.46	878.43	882.62	882.63
Median (50%)	882.09	882.59	883.12	878.70	882.92	883.08
75.0%	883.01	883.02	883.59	879.31	883.22	883.30
90.0%	883.34	883.58	884.04	880.14	883.61	883.54
97.5%	883.52	883.79	884.47	880.64	884.01	883.63
Max	883.56	883.85	884.94	881.05	884.12	883.71

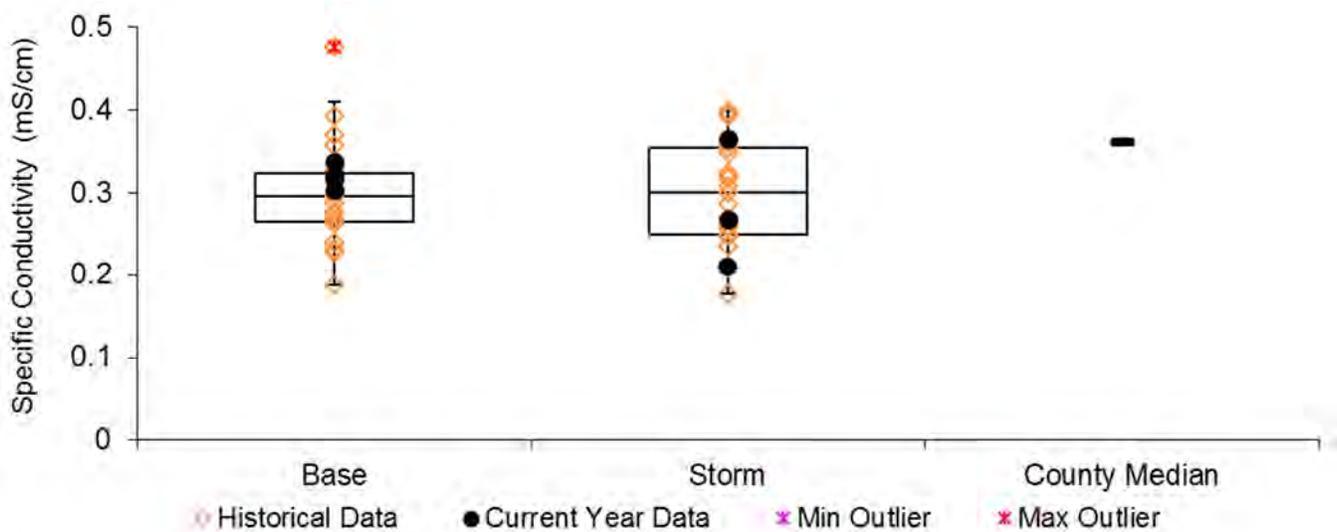
Specific conductivity was acceptably low in the West Branch of the Sunrise River. Median specific conductivity this year was 0.311 mS/cm. This is notably lower than the median for 49 Anoka County streams of 0.420 mS/cm. Specific conductivity was lower during storms (baseflow median 0.319 mS/cm, stormflow median 0.240 mS/cm), suggesting that stormwater runoff contains fewer dissolved pollutants than the surficial water table that feeds the river during baseflow. High baseflow specific conductivity has been observed in many other area streams too. This has been studied extensively leading to the determination that the largest cause is road salts that have infiltrated into the shallow aquifer.

Specific conductivity during baseflow and storm conditions. Orange diamonds are historical data from previous years and black circles are 2018 readings. Box plots show the median (middle line), 25th and 75th percentile (ends of box), and 10th and 90th percentiles (floating outer lines).

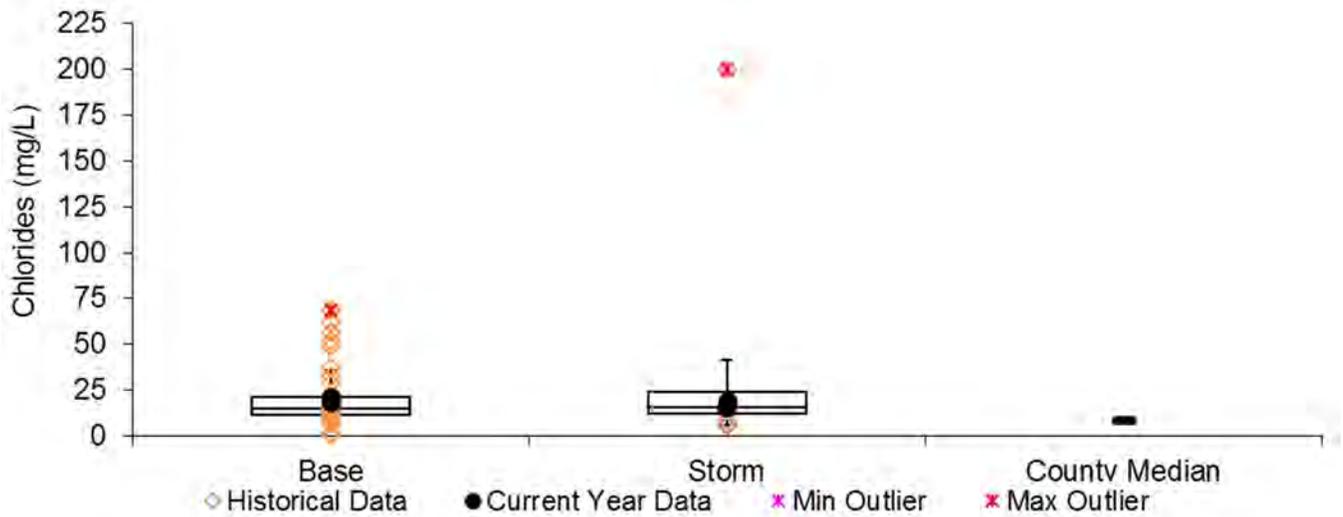
Chlorides in the West Branch of the Sunrise River are higher than the median for Anoka county. This year median chlorides were 21.0 and 15.9 mg/L during base and stormflows, respectively, well below the state standard of 230 mg/L. This mirrors the pattern seen in specific conductivity of higher readings during baseflow and further supports the finding that road salts seeping into the shallow aquifer is a primary cause of higher baseflow chloride and high specific conductivity readings.

Chlorides during baseflow and storm conditions. Orange diamonds are historical data from previous years and black circles are 2018 readings. Box plots show the median (middle line), 25th and 75th percentile (ends of box), and 10th and 90th percentiles (floating outer lines).

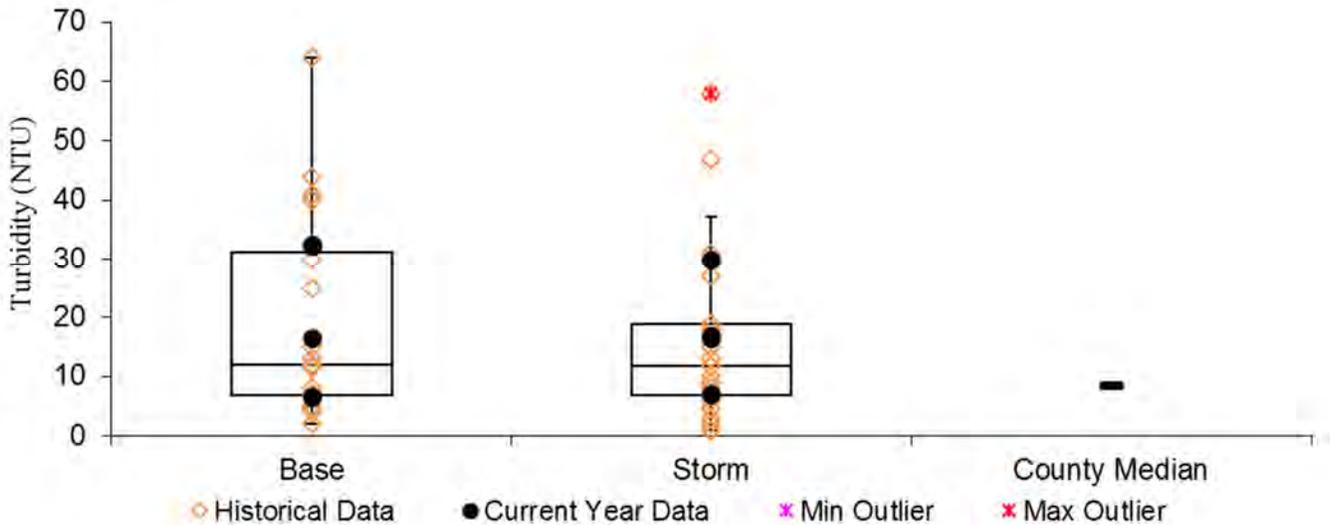
Turbidity during baseflow and storm conditions Orange diamonds are historical data from previous years and black circles are 2018 readings. Box plots show the median (middle line), 25th and 75th percentile (ends of box), and 10th and 90th percentiles (floating outer lines).

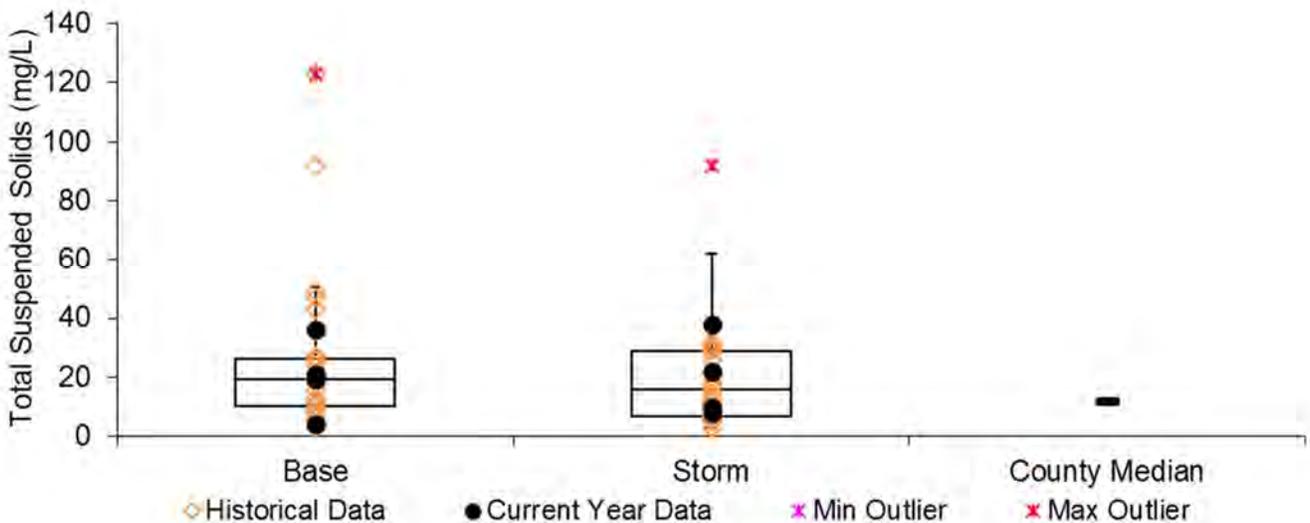
Total suspended solids during baseflow and storm conditions Orange diamonds are historical data from previous years and black circles are 2018 readings. Box plots show the median (middle line), 25th and 75th percentile (ends of box), and 10th and 90th percentiles (floating outer lines).

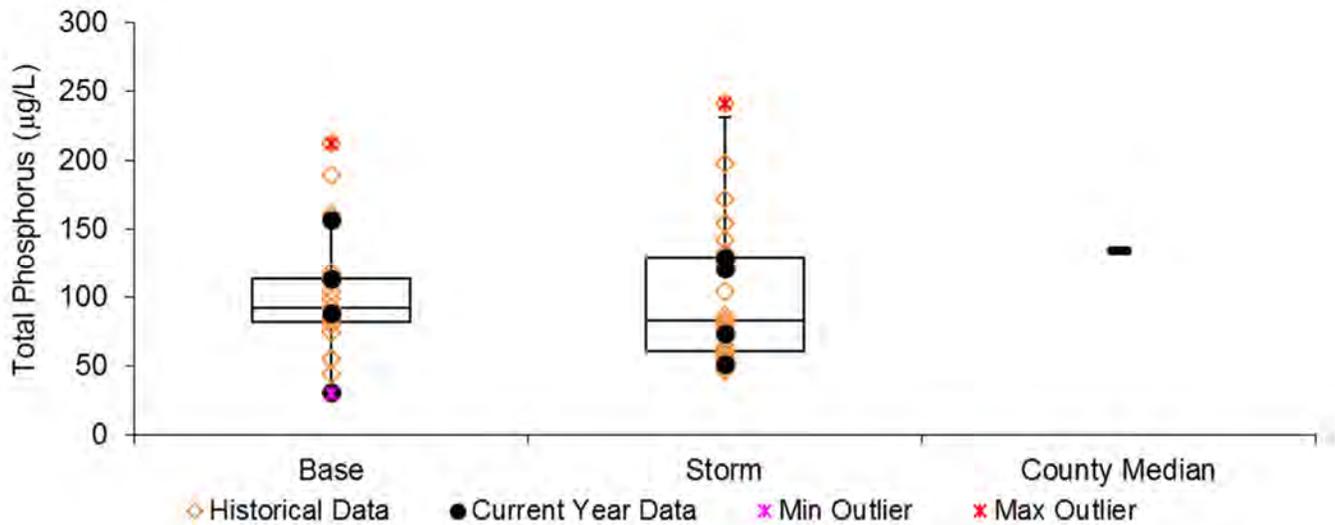
The nutrient phosphorus is one of the most common pollutants in our region, and can be associated with urban runoff, agricultural runoff, wastewater, and many other sources. Total phosphorus (TP) in the West Branch of the Sunrise River often exceeds the state standard of 100 µg/L. In 2018 this level was exceeded on 4 of 8 sampling occasions representing both storm and baseflow conditions. The median phosphorus concentration in the West Branch of the Sunrise River across all years monitored is 88.0 µg/L, and in 2018 was 101.5 µg/L. Over all years sampled 21 of 48 samples have exceeded the standard. There is not a large difference between storm and base

These phosphorus levels are common for the area. In the case of the West Branch of the Sunrise River phosphorus levels are, at least in part, reflective of conditions of Martin Lake about 3 miles upstream from the sampling site. Martin Lake is impaired for excess phosphorus, with a summertime average of 93.4 $\mu\text{g/L}$ during the last 10 years. Water quality improvements to Martin Lake will benefit the river downstream. Recent upstream projects including carp barriers, carp harvests, and stormwater retrofits coincide with improved conditions in upstream lakes, but those benefits are not yet apparent in the West Branch of the Sunrise River.

Total phosphorus during baseflow and storm conditions. Orange diamonds are historical data from previous years and black circles are 2018 readings. Box plots show the median (middle line), 25th and 75th percentile (ends of box), and 10th and 90th percentiles (floating outer lines).

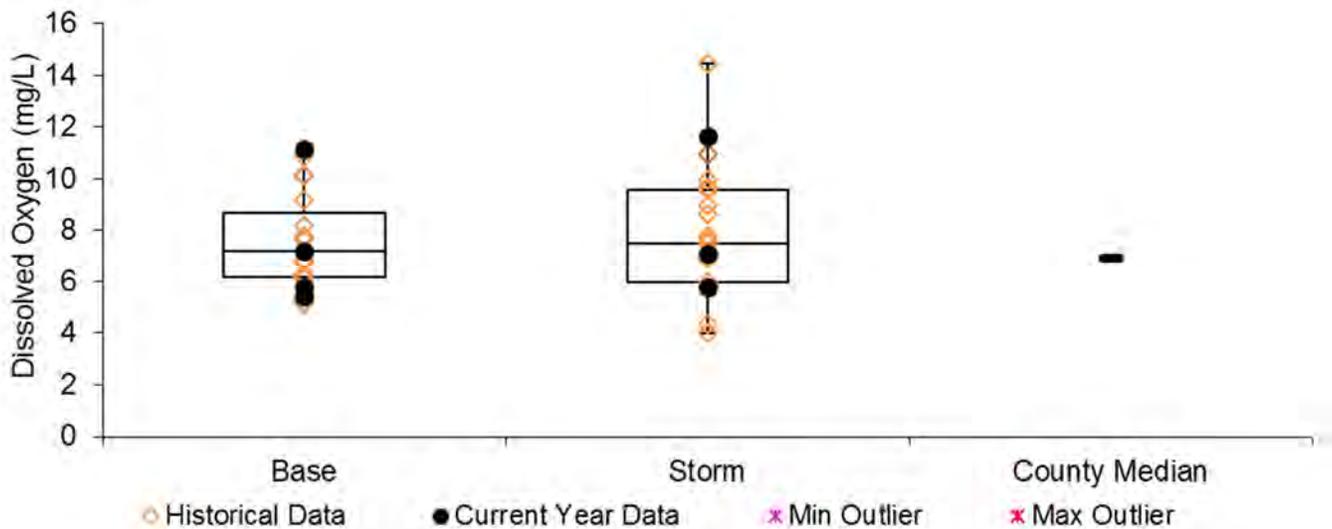
For the West Branch of the Sunrise River there are two datasets to consider. First, spot measurements were taken with the other water quality monitoring described in this report. Dissolved oxygen has been found at less than 5 mg/L on three different occasions. All were during storm events, occurring in 2003, 2012 and 2015. In 2018 there were no instances of DO dipping below 5 mg/L but sampling did not occur in early morning. Secondly, MPCA took around-the-clock DO measurements for eight days in 2012. They found DO dipped below 5 mg/L every morning. The river has been designated as impaired for poor fish and invertebrate communities although it is not listed as impaired for DO.

Dissolved oxygen results during baseflow and storm conditions Orange diamonds are historical data from previous years and black circles are 2018 readings. Box plots show the median (middle line), 25th and 75th percentile (ends of box), and 10th and 90th percentiles (floating outer lines).

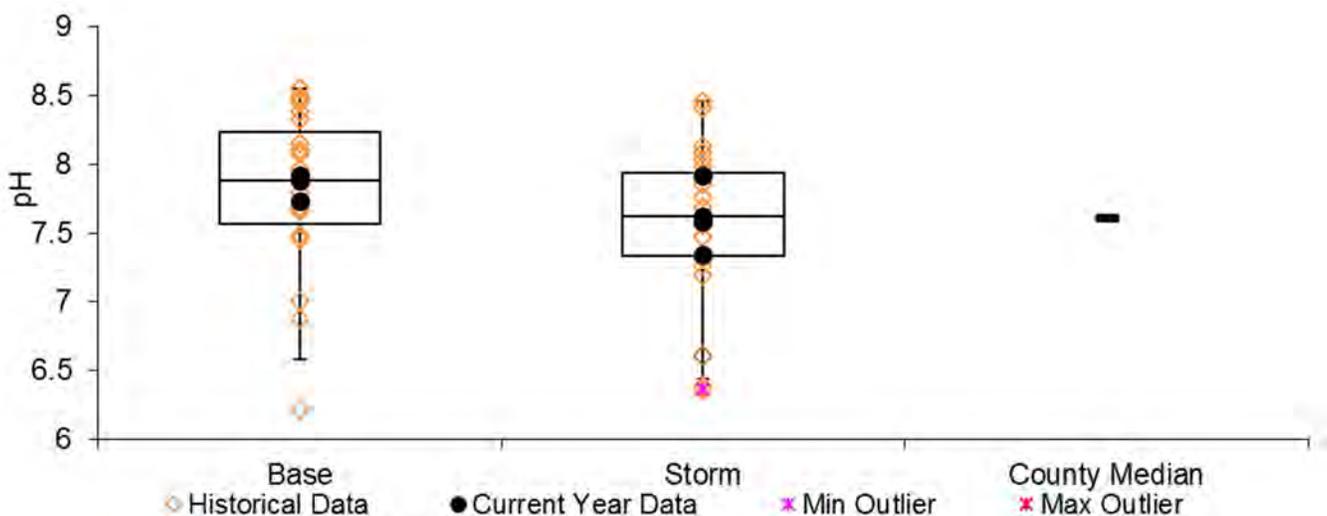
pH results during baseflow and storm conditions Orange diamonds are historical data from previous years and black circles are 2018 readings. Box plots show the median (middle line), 25th and 75th percentile (ends of box), and 10th and 90th percentiles (floating outer lines).

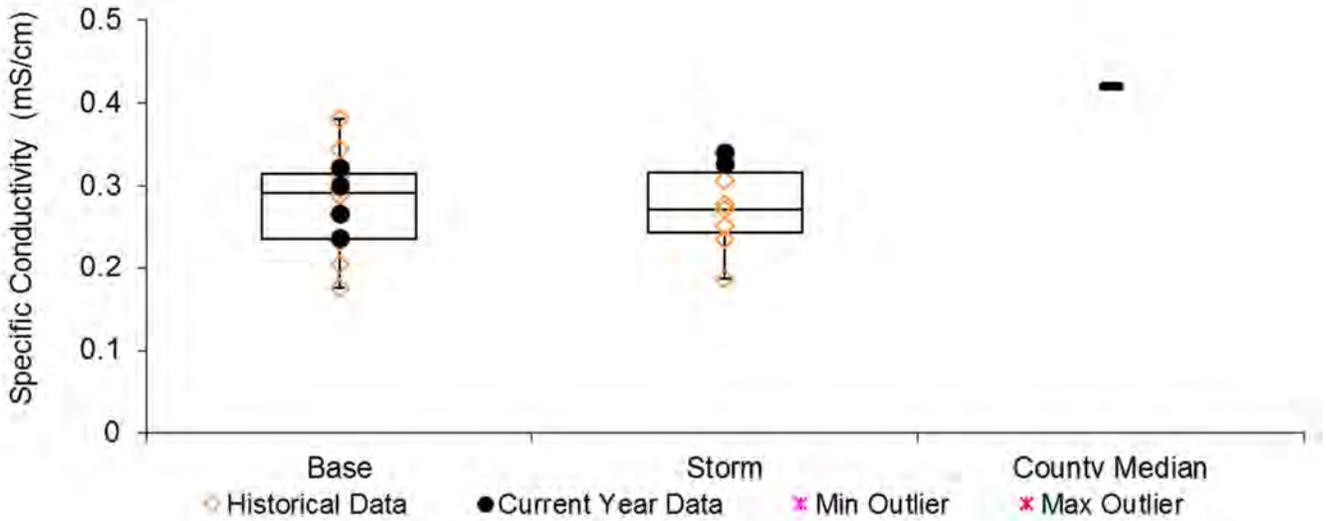
Specific conductivity during baseflow and storm conditions Orange diamonds are historical data from previous years and black circles are 2018 readings. Box plots show the median (middle line), 25th and 75th percentile (ends of box), and 10th and 90th percentiles (floating outer lines).

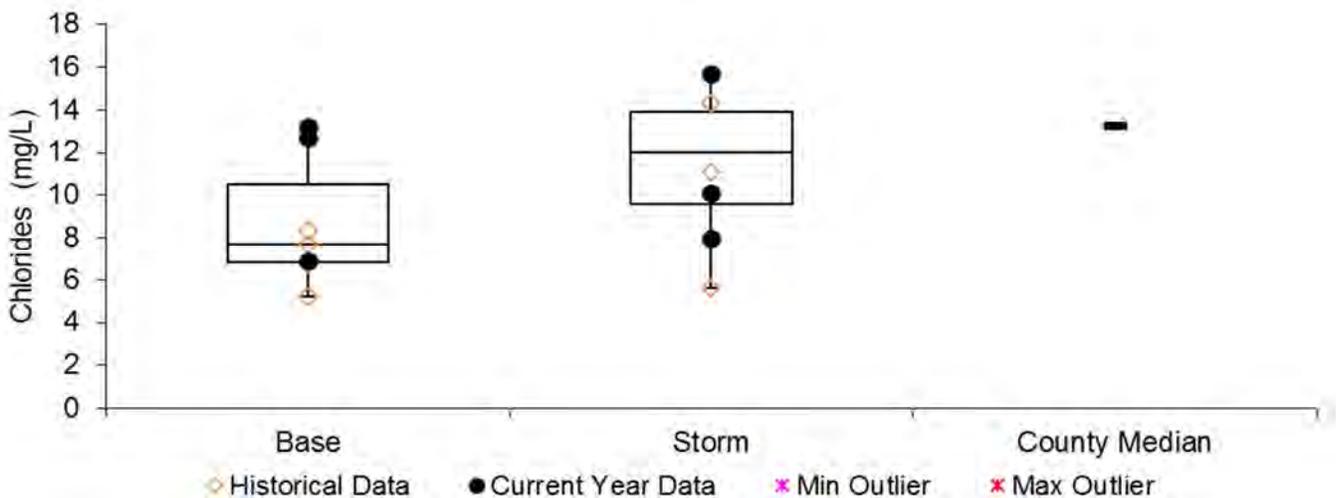
Chlorides during baseflow and storm conditions Orange diamonds are historical data from previous years and black circles are 2018 readings. Box plots show the median (middle line), 25th and 75th percentile (ends of box), and 10th and 90th percentiles (floating outer lines).

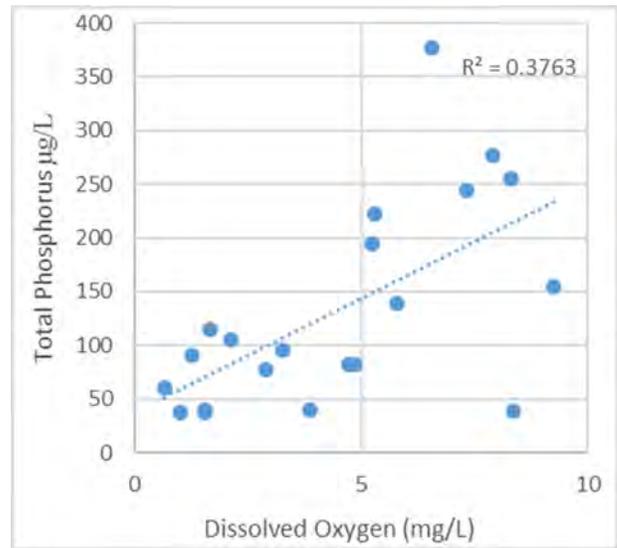
Total phosphorus as a function of dissolved oxygen showing that higher phosphorus occurs with lower dissolved oxygen.

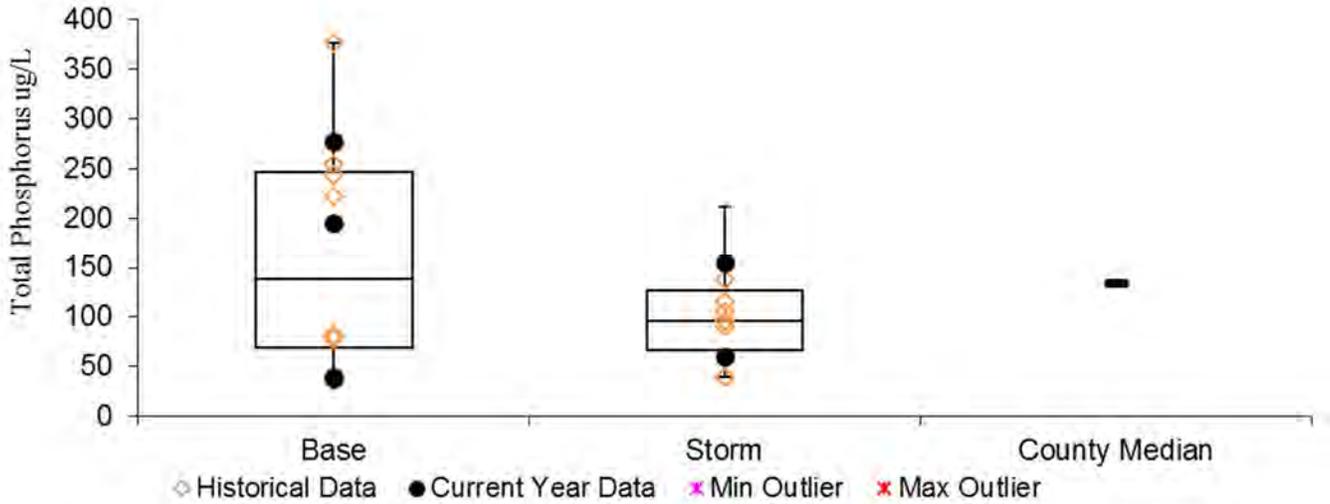
Total phosphorus during baseflow and storm conditions Orange diamonds are historical data from previous years and black circles are 2018 readings. Box plots show the median (middle line), 25th and 75th percentile (ends of box), and 10th and 90th percentiles (floating outer lines).

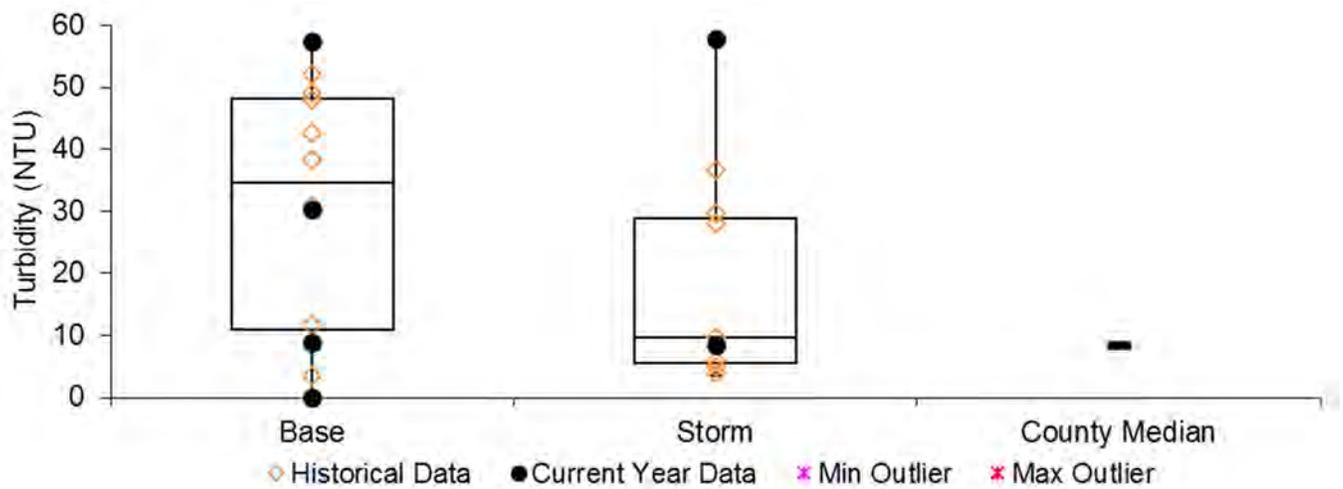
Turbidity during baseflow and storm conditions. Orange diamonds are historical data from previous years and black circles are 2018 readings. Box plots show the median (middle line), 25th and 75th percentile (ends of box), and 10th and 90th percentiles (floating outer lines).

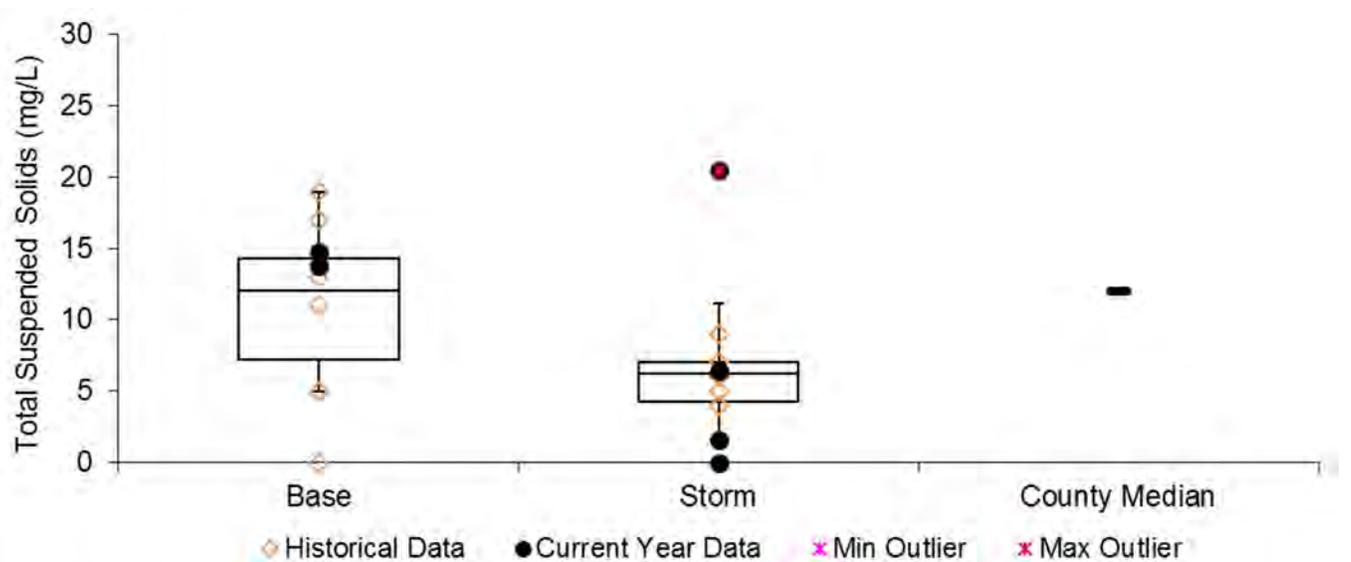
Total suspended solids during baseflow and storm conditions. Orange Diamonds are historical data from previous years and black circles are 2018 readings. Box plots show the median (middle line), 25th and 75th percentile (ends of box), and 10th and 90th percentiles (floating outer lines).

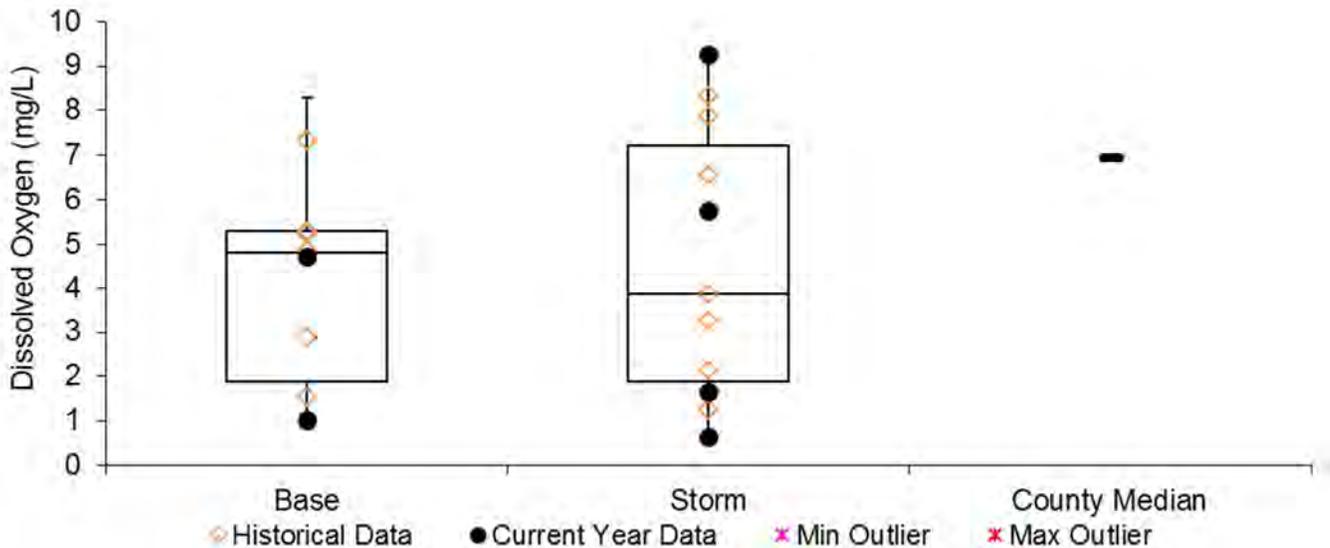
Dissolved oxygen results during baseflow and storm conditions. Orange diamonds are historical data from previous years and black circles are 2018 readings. Box plots show the median (middle line), 25th and 75th percentile (ends of box), and 10th and 90th percentiles (floating outer lines).

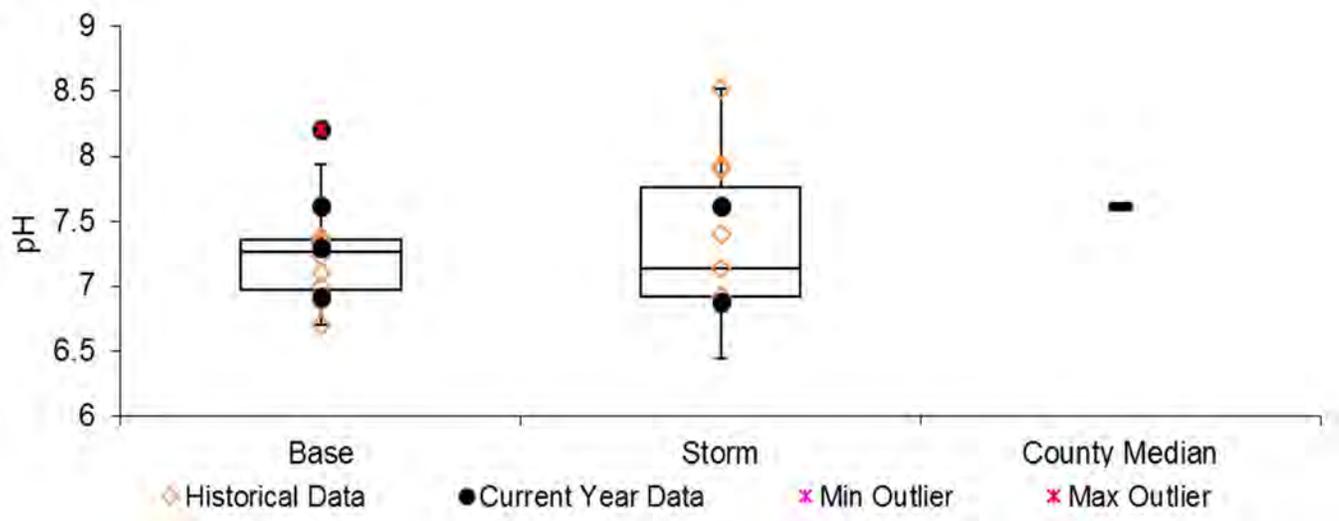
pH results during baseflow and storm conditions. Orange diamonds are historical data from previous years and black circles are 2018 readings. Box plots show the median (middle line), 25th and 75th percentile (ends of box), and 10th and 90th percentiles (floating outer lines).

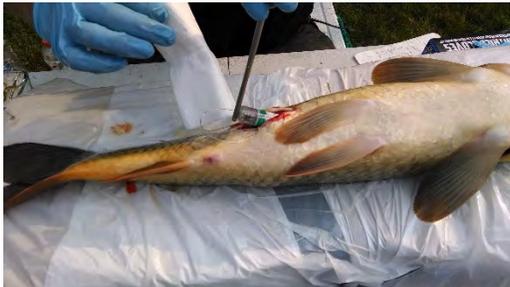
Radio transmitter being surgically implanted in a carp. 40 carp were implanted with radio loggers, 20 each from Typo and Martin Lakes. Radio loggers will help track the schooling, feeding, and movement patterns of the carp to aide in future harvesting efforts.

- Radio telemetry monitoring of carp in Typo and Martin Lakes.
- 209 carp heads were preserved for aging during winter 2017-18. Fish age is determined by internal balance organs called otoliths. The population age structure reveals the spawning history.
- 3,366 carp were removed from Martin Lake and 3,552 carp were removed from Typo Lake

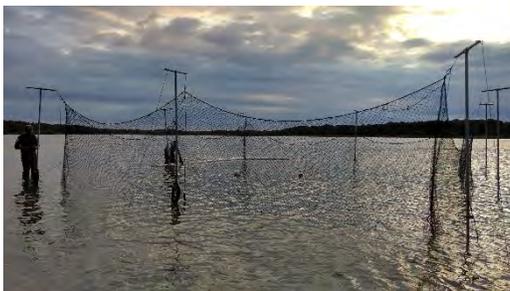
A sprung box net in Typo Lake. Nets were set, baited, and sprung at four sites each in Typo and Martin Lake for a total of 30 nettings on 8 different days from June through September, 2018.

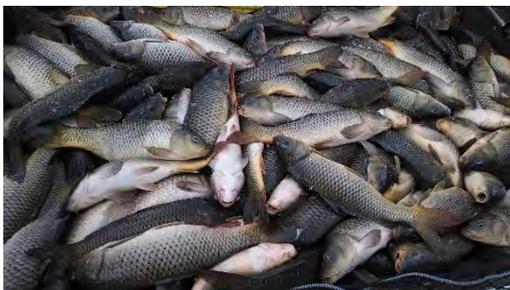
A boat full of harvested carp. A total of 3,552 carp were removed from Typo Lake during the summer of 2018. 3,366 carp were removed from Martin Lake during August through September 2018. Harvest efforts in both lakes will continue through 2019.
